**A.M.I.S**  
**ASBESTOS SURVEY REPORT**

**Place:** Bill Quay Park Pavilion

**Address:** Bill Quay Park  
Station Road  
Bill Quay

This report is for an asbestos management survey to HSG264.

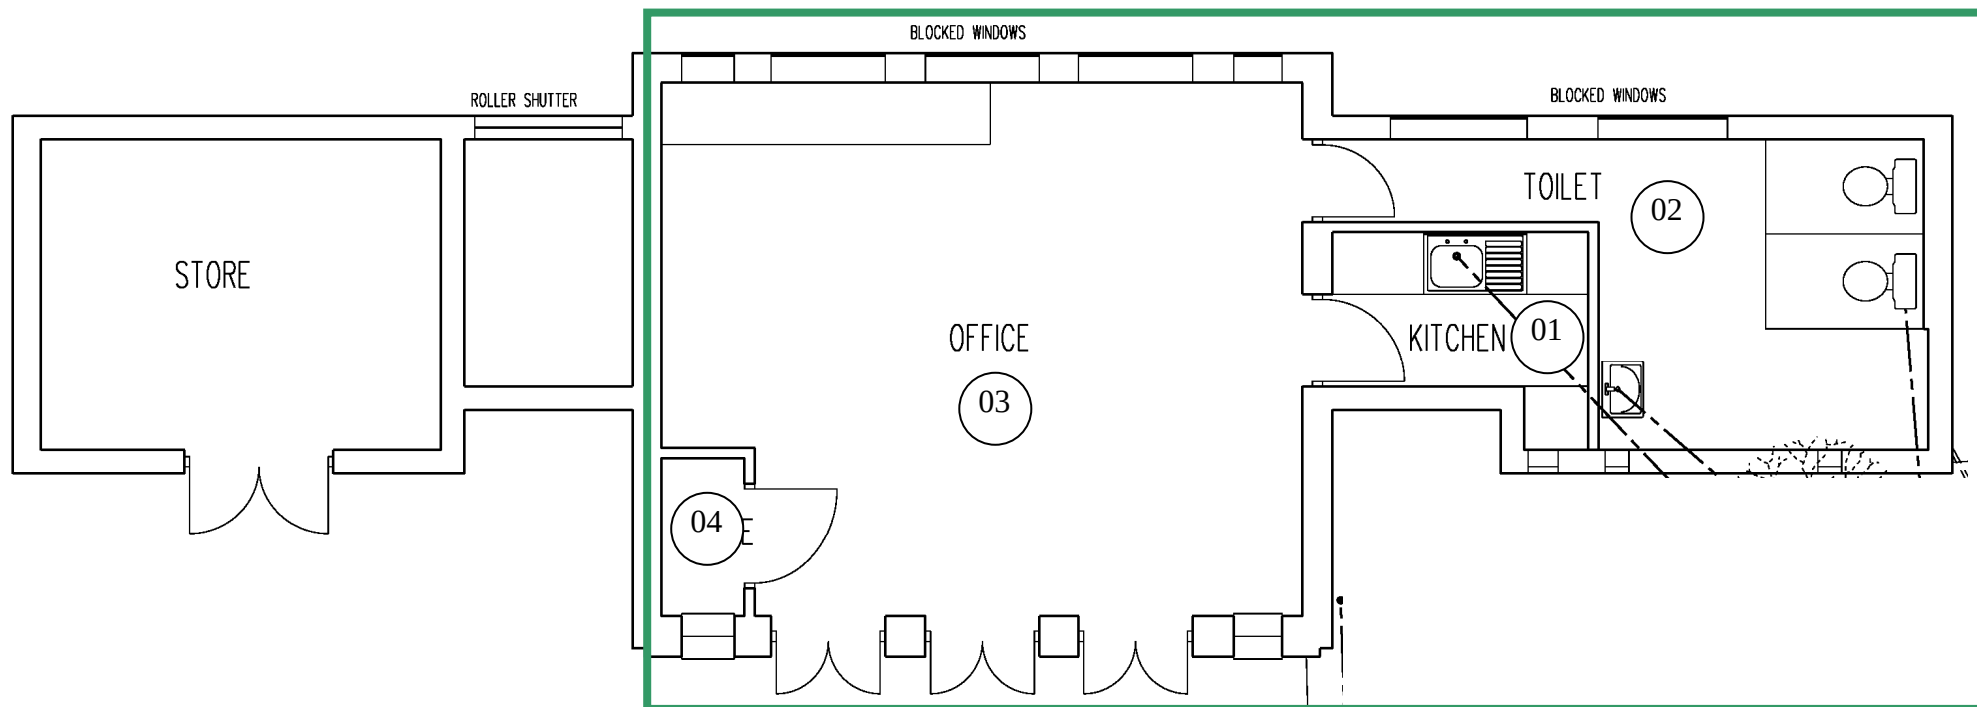
| | | | <b>ASBESTOS SURVEY PLAN</b><br><b>THIS PLAN MUST BE READ IN CONJUNCTION WITH THE FULL SURVEY REPORT</b><br><small>ALL ACM LOCATIONS ARE INDICATIVE<br/> REFERENCE TO ALL AREAS OF NO ACCESS CAN BE FOUND IN THE SURVEY REPORT<br/> ACM NUMBERS AS DETAILED REFER TO ASBESTOS INSTALLATIONS ONLY.<br/> REFERENCE TO NON-ASBESTOS INSTALLATIONS CAN BE FOUND IN THE SURVEY REPORT.</small> | |

MARKED CAD PLANS
